### Site Reconnaissance Report, Puerto Peñasco, Sonora, Mexico

| Date: Mach 31, 2004 | Time: 1:00 p.m. | Location: Las Conchas Residential Development to Genesis, SA, CV | | Coordinates: Not available |
| Team Leader: Barney P. Popkin | | | | Mexican Cell Phone: 638-386-76-63 |

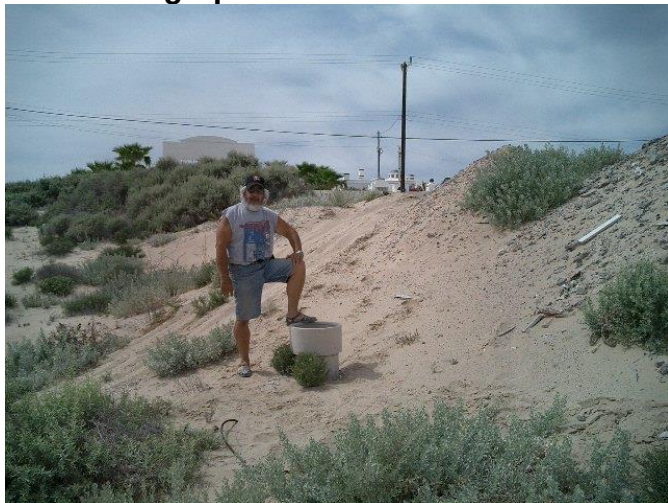
1. Las Conchas Production Well #12, abandoned, 12-in. dia., asbestos-cement casing, 1974 – need secured cover to keep out kids and trash; needs debris removal from well

Item 1. Las Conchas Production Well #12, abandoned

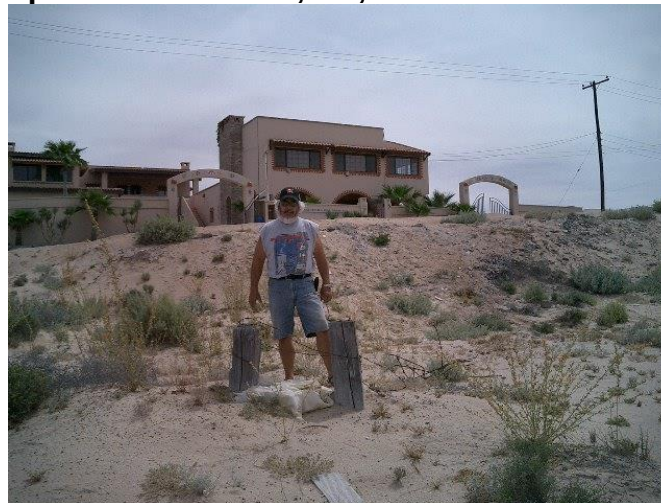
2. Las Conchas Production Well #5, abandoned, 16-in. dia. polyvinyl chloride (PVC) production well
3. Las Conchas Observation Well #5, abandoned, 6-in. dia. PVC observation well

Item 2. Las Conchas Production Well #5, abandoned

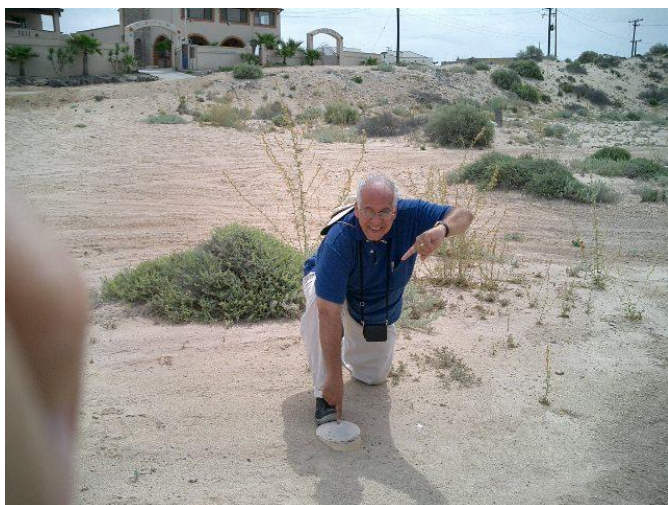
Item 3. Las Conchas Observation Well #5, abandoned

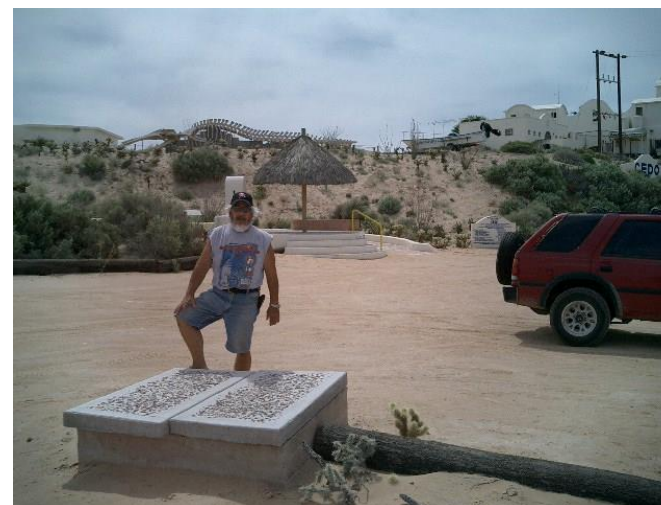
4. Las Conchas Observation Well #2, active, 6-in. dia. PVC observation well at CEDO
5. Las Conchas Production Well #2, abandoned, 16-in. dia. PVC production well at CEDO

Item 4. Las Conchas Observation Well #2, active

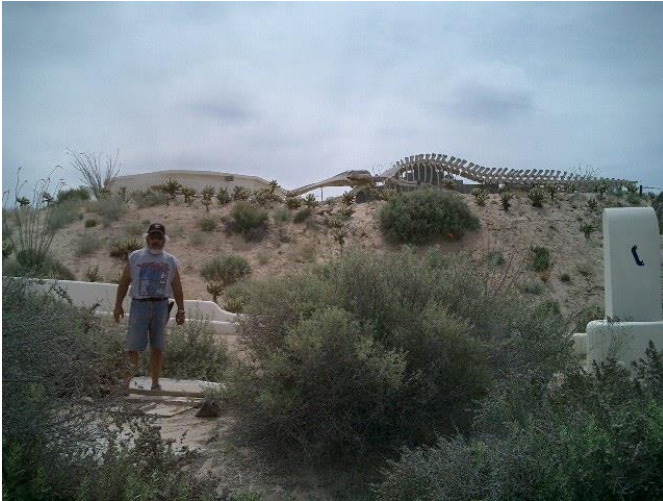
Item 5. Las Conchas Production Well #2, abandoned

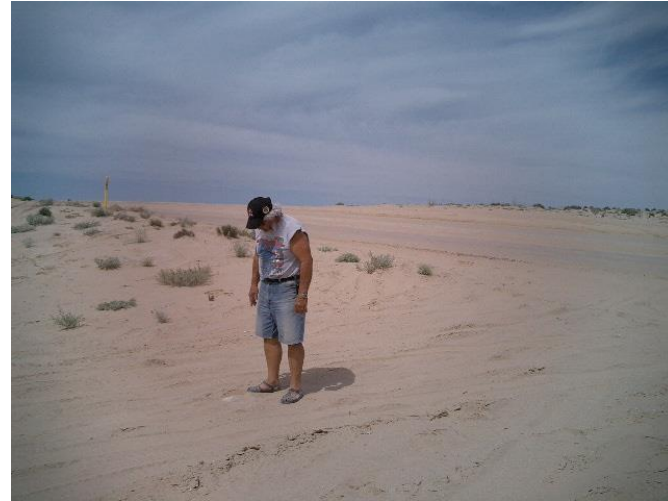
6. Las Conchas Observation Well #3, abandoned, 6-in. dia. PVC observation well
7. Las Conchas Production Well #3, abandoned, 16-in. dia. PVC production well

Item 6. Las Conchas Observation Well #3, abandoned

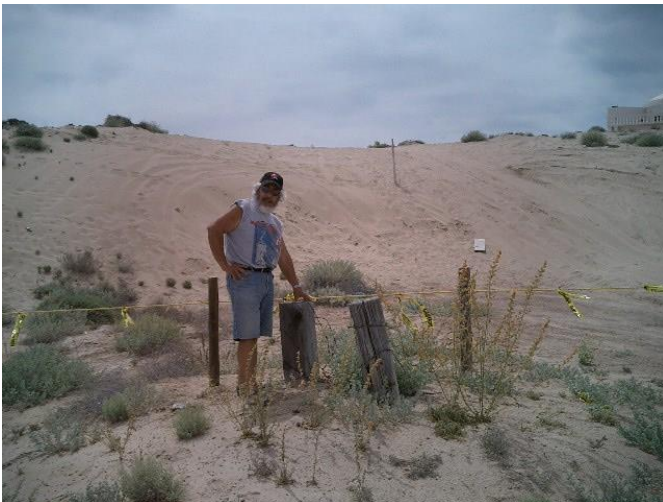
Item 7. Las Conchas Production Well #3, abandoned

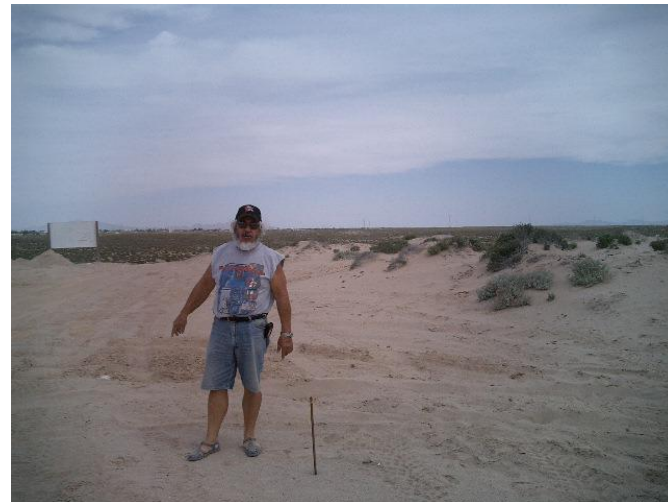
8. Las Conchas Observation Well #4, abandoned, 6-in. dia. PVC observation well
9. Las Conchas Production Well #4, active, 16-in. dia. PVC production well

Item 8. Las Conchas Observation Well #4, abandoned

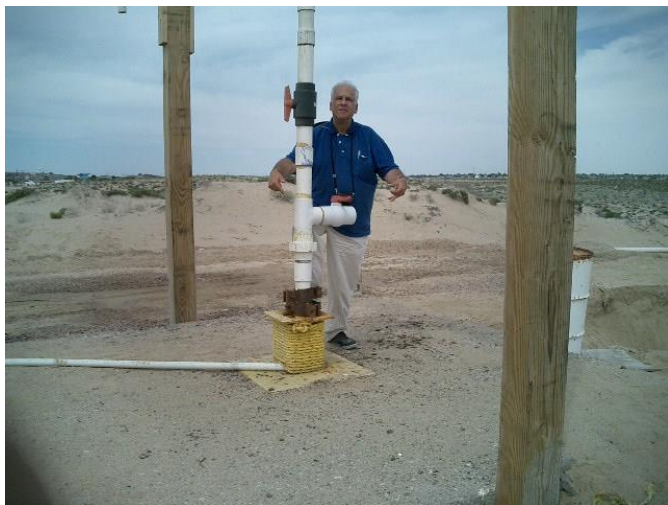
Item 9. Las Conchas Production Well #4, active

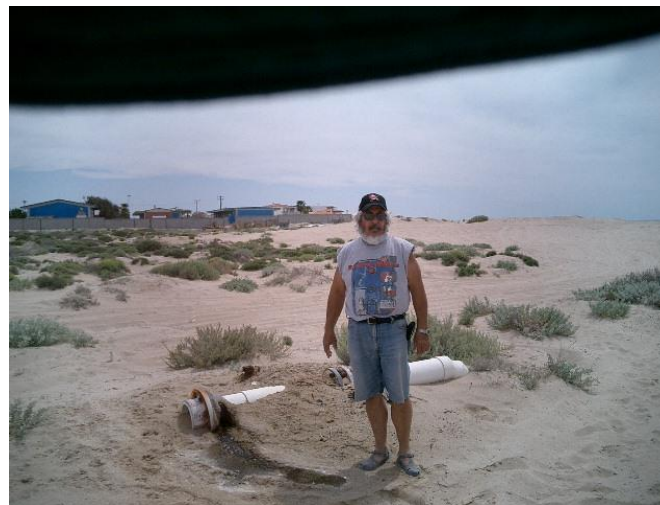
Item 10. UEP Production Well #6, abandoned

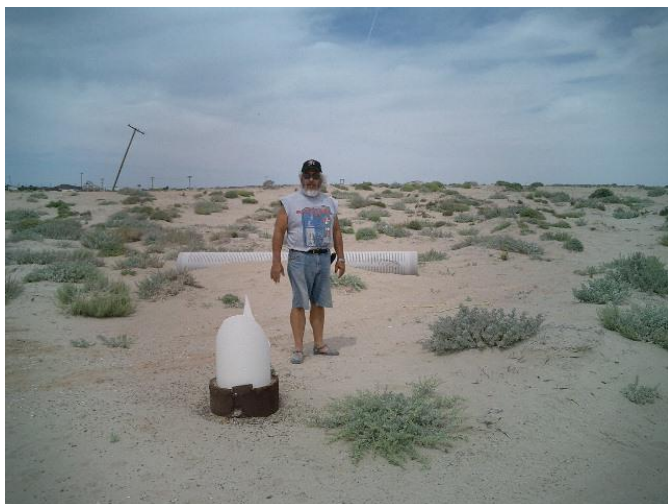
10. UEP Production Well #6, abandoned
11. UEP, 1<sup>st</sup> replacement for Production Well #6, abandoned, 14-in. dia. PVC well, DICTUS – well failed because screen was inadequate

Item 11. UEP, 1<sup>st</sup> replacement for Production Well #6, abandoned

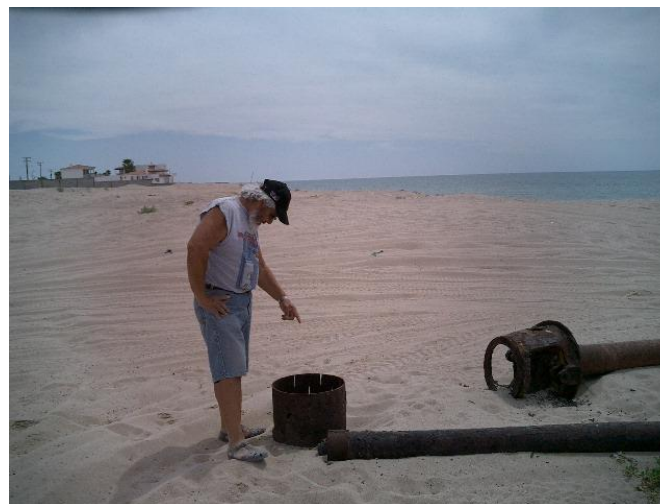
12. DICTUS 2<sup>nd</sup> replacement for Production Well #6, abandoned – well collapsed with sand as it was not screened but only opened to the coquina

Item 12. DICTUS 2<sup>nd</sup> replacement for Production Well #6, abandoned

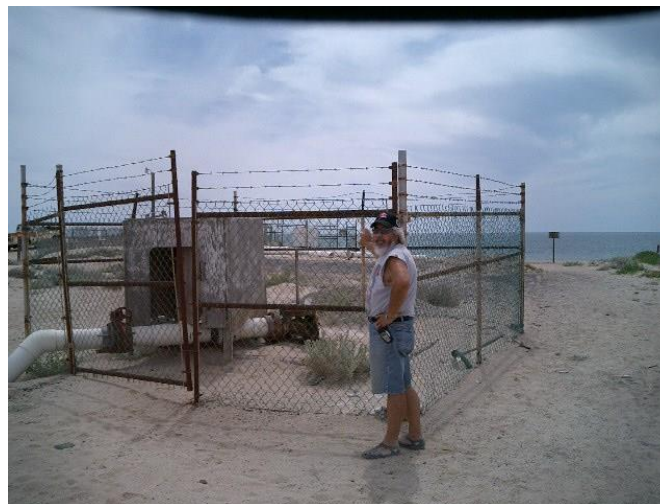
16. Genesis, green susubia ornamental halophytes
17. Genesis, dry lake
18. Genesis, Production Well #8, unused

Item 18. Genesis, Production Well #8, unused

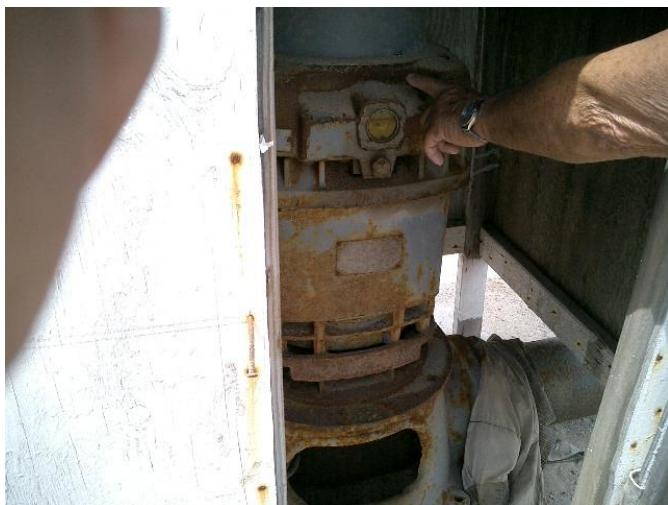
- 19. Genesis, Production Well #9, unused – oiled turbine, not suitable for shrimp or fish water supply because of pump-oil contamination
- 20. CICTUS, two wells on beach
- 21. Genesis Produccion de Postlarvas
- 22. Genesis Acuacultura Halofitas
- 23. Genesis, mangrove tree
- 24. Genesis, atriplex
- 25. Genesis, tilapia pond
- 26. Genesis, senior shrimp in tank
- 27. Genesis, wild jasmine

Item 19. Genesis, Production Well #9, unused
